Manhole Inspection Summary

Manhole # S51U1_005MH

Location Address: **2000 Frankfurst Ave.**

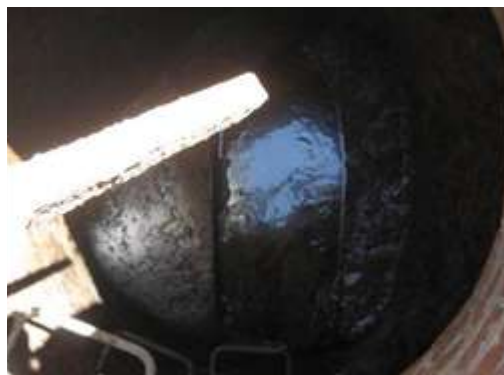
Top View

An iron lock bar prevented the clear top view.

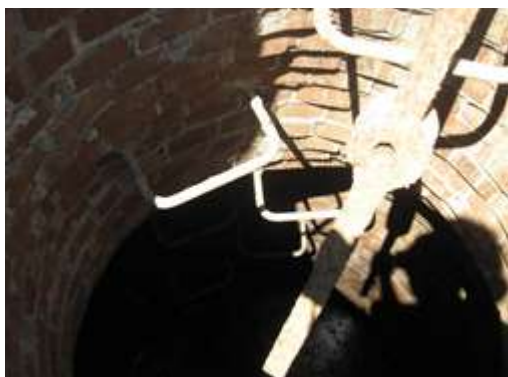
Steps Count: **6** Missing: **0** ☒ **Corroded**

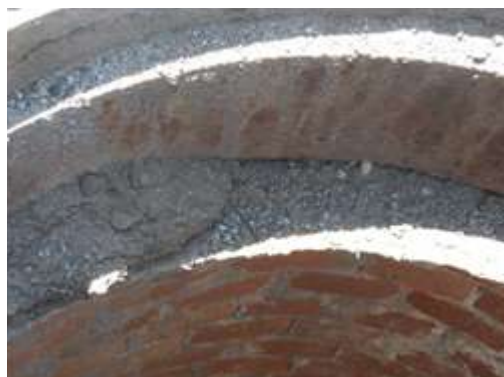
Defect 1

Frame Offset: **2.5** (in.) Condition: ☒ Sound ☐ Cracked ☐ Leaks

Frame Offset

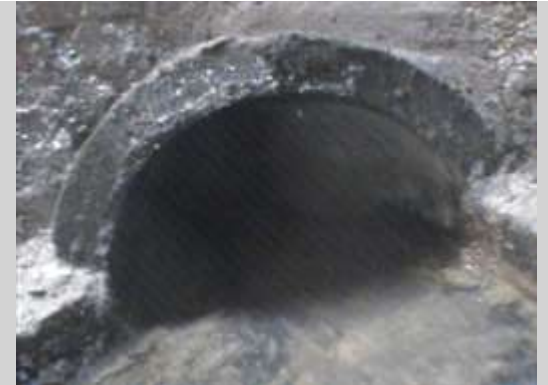
12 O'Clock Outflow

18 in. Circular Gravity Sewer
Pipe Out @ 12 O'Clock

Pipe Height: **18** (in.) Rod and Bar (Angled)
Pipe Material: **DIP/CI** ☐ Pipe Lined
Invert Depth: **12.18** (ft.) Flow Characteristics: **Fast**
Deposits: ☒ None ☐ Mud ☐ Sludge ☐ Debris ☐ Grease
Silt Depth: (in.) Deposits Extent:
Infiltration: **None** Pipe Seal Cond: **Sound**

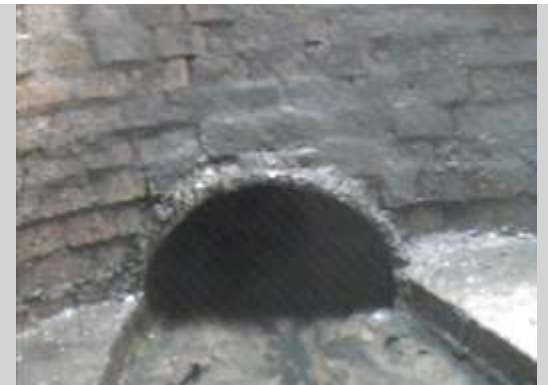
6 O'Clock Inflow

18 in. Circular Gravity Sewer
Pipe In @ 6 O'Clock

Pipe Height: **18** (in.) Rod and Bar (Angled)
Pipe Material: **DIP/CI** ☐ Pipe Lined
Invert Depth: **12.10** (ft.) Flow Characteristics: **Fast**
Deposits: ☒ None ☐ Mud ☐ Sludge ☐ Debris ☐ Grease
Silt Depth: (in.) Deposits Extent:
Infiltration: **None** Pipe Seal Cond: **Sound**
